Manhole Inspection Summary

Manhole # S17G__005MH

Insp Date: **10/5/07 10:08 AM**

Location Address: **2327 LEXINGTON-VINE**

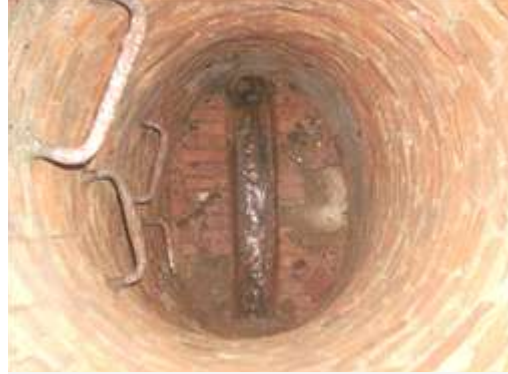
Top View

Frame Offset: **2** (in.) Condition: ☒ Sound ☐ Cracked ☐ Leaks

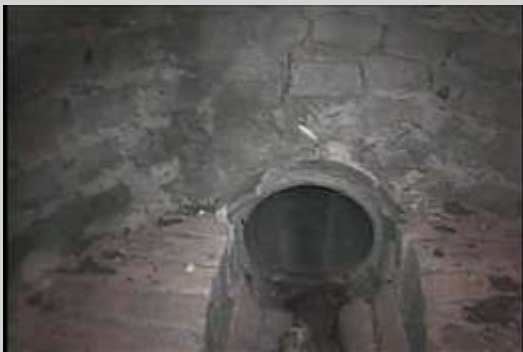
12 O'Clock Outflow

8 in. Circular Gravity Sewer
Pipe Out @ 12 O'Clock

Pipe Height: **8.4** (in.) Rod and Bar (Angled)
Pipe Material: **Clay** ☐ Pipe Lined
Invert Depth: **9.79** (ft.) Flow Characteristics: **Slow**
Deposits: ☒ None ☐ Mud ☐ Sludge ☐ Debris ☐ Grease
Silt Depth: (in.) Deposits Extent:
Infiltration: **None** Pipe Seal Cond: **Sound**
